Fix for Canon Pixma IP4000R Error Code 5C00

By Bret A. Bennett, July 2011

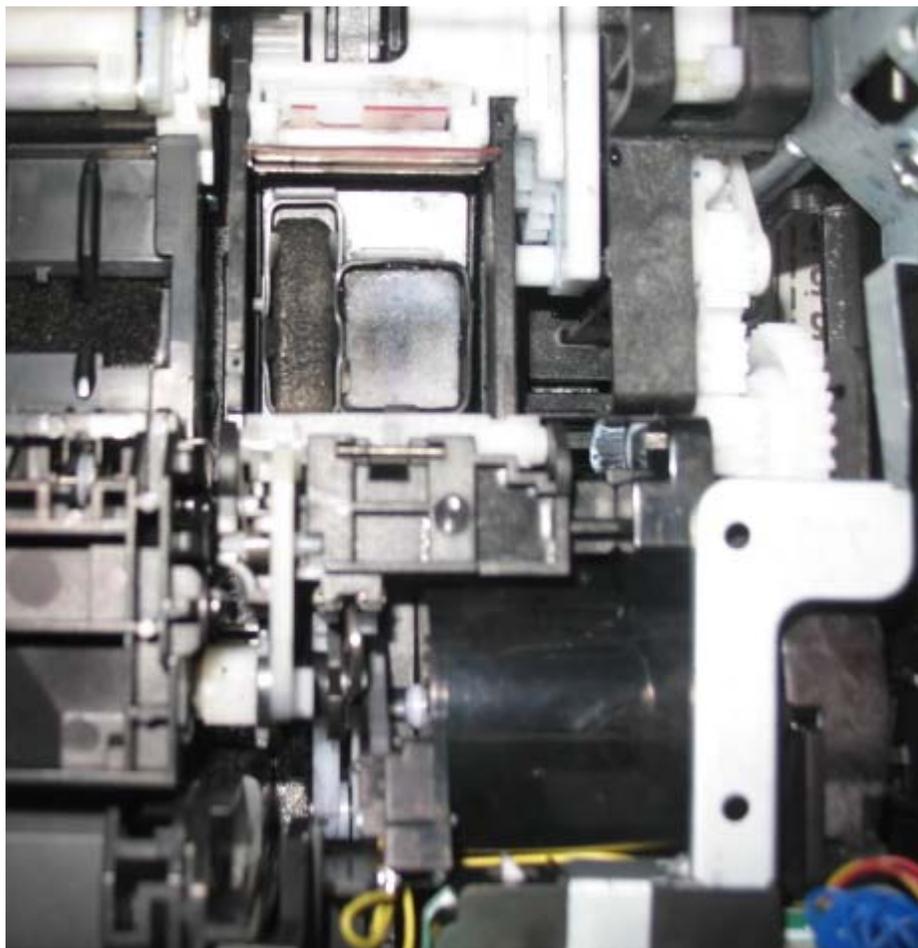
The 5C00 error is well documented on the web as a “purge tank” error. The purge tank is the absorbent sponges (or pads) in the bottom of the printer that absorbs ink from normal print head maintenance and cleaning jobs. Error 5C00 is usually seen when the tank (ie. pads) starts to get somewhat full and prevent the “purge unit” from being able to vacuum a little ink from the print head. The purge unit consists of several moving parts (including a pump) that sit under the print head when it is parked on the right side of the printer. Before I begin to discuss individual parts, here is an unmarked top view of the purge unit area:

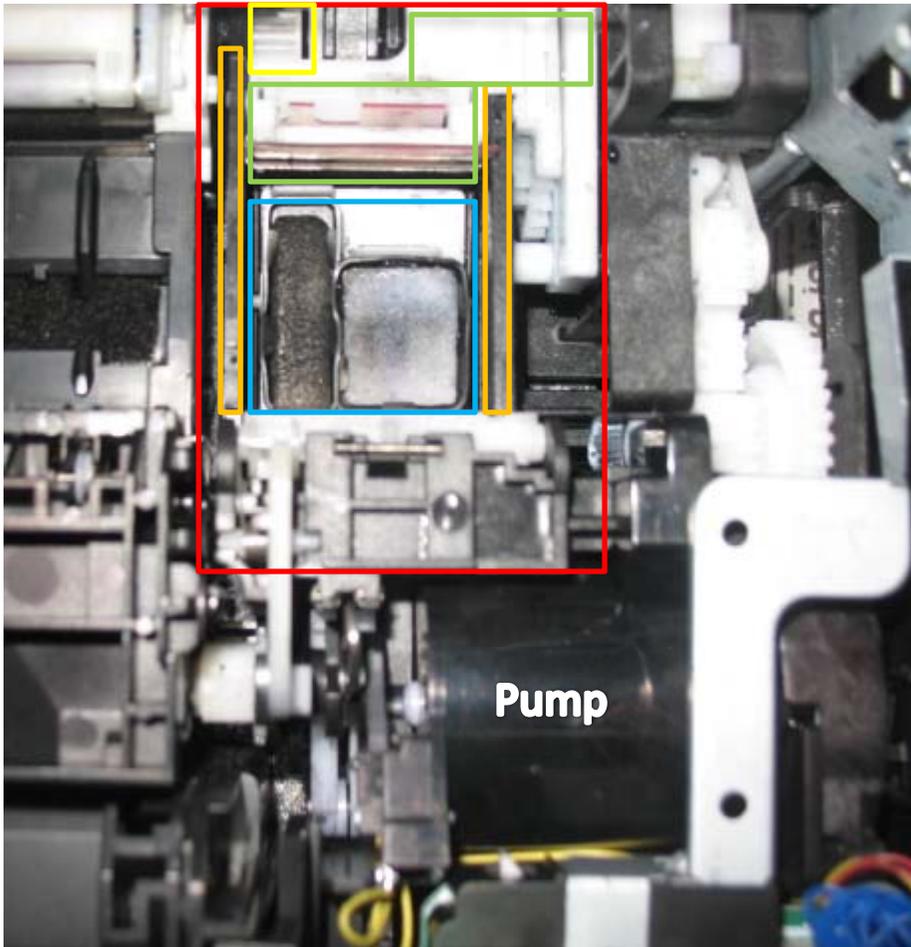
Incidentally, Figure 1 shows a top view of the purge unit outlined in red:

When I operated the printer with the covers off, the loud clicking noise was clearly coming from a gear (see the yellow box in Figure 1). This gear moves the print head “wiper” (green boxes in Figure 1) forward across the print head when the purge vacuum pads (blue box in Figure 1) drop down. Fortunately, there was no apparent damage to the gear’s teeth.

To make a long story short, the print head wiper’s guides (orange boxes in Figure 1) had become coated with semi-solid ink (thick like auto grease). These guides are simply black plastic flats that are part of the purge tank assembly case. The clicking noise was occurring because the wiper (which is spring loaded from the rear) was not snapping back rearward fast enough during the print head priming/wiping process. Again, the wiper is the green boxed area in Figure 1. Please read on . . .

This lever has some sort of molded-in protrusion/pin that interfaces with the right side of the “clicking gear” (that I show in the yellow box in Figure 1). When this lever is not moving back in tandem with the print head wiper (ie. btw, they’re actually the same solid piece of white plastic/nylon), you get the loud clicking noise and the on-screen 5C00 error. Now the fix:

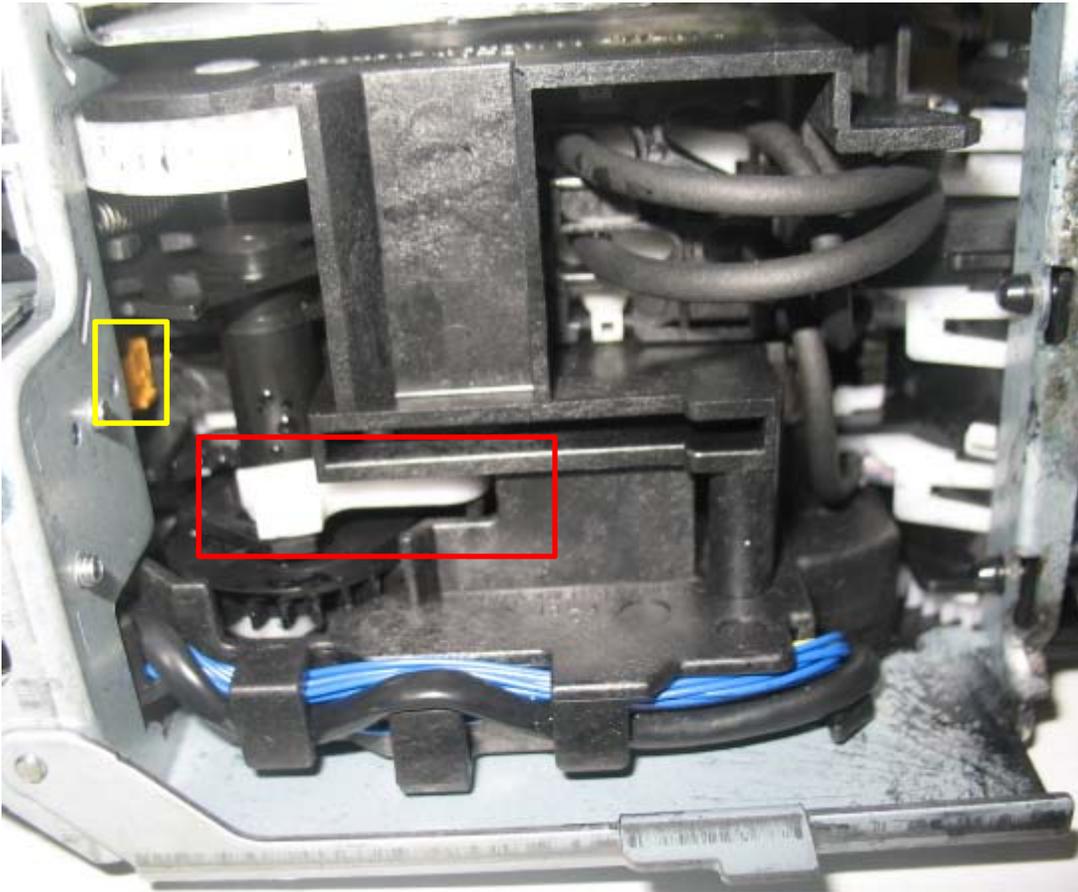
When the wiper moves to its rearward position, it also has a lower extension “lever” that can be seen under the printer. See the red box in Figure 2 below:

(running under it), and a photo sensor on a small stand-alone pc board (see yellow box in Figure 2).

- 7) If you have the strength (or a helper), you can tilt the print engine about 45° up on the plastic bowl in the sink and slowly spray off any significant ink runoff that may be still clinging to parts under the purge or carriage units unit. Again, with the exception of that photo sensor (see yellow box in Figure 2), keep the water off the electronics

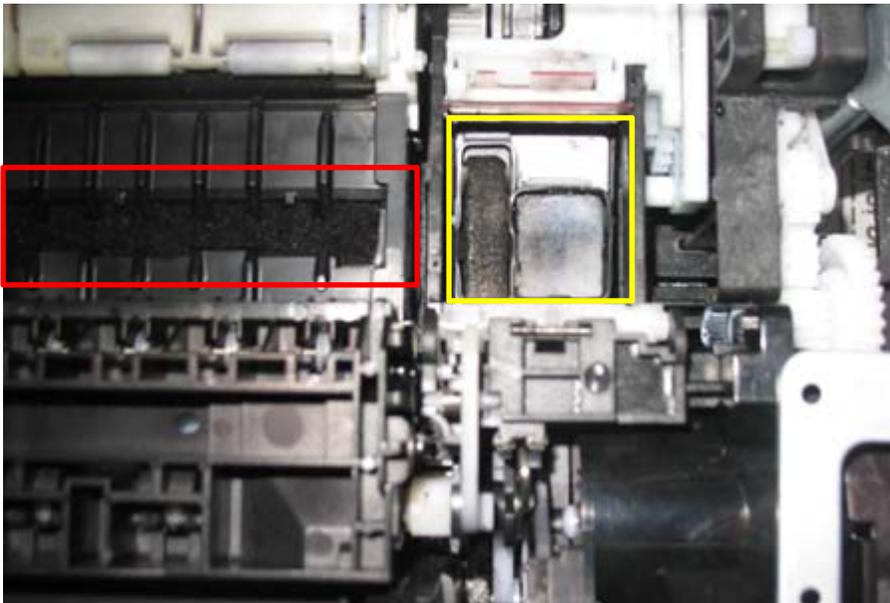
Note above in Figure 4 that my brushing had moved the left black ink pad slightly forward out of its soft rubber basin (see yellow box). Now see Figure 5 below where I have made sure that the ink pads are centered in place and have the little rubber “clamps” over top of the pads, thus securing the pads.

- 3) Use a brush suitable for electronics and brush off the old ink mess. Slowly flush it straight down through the printer with the water sprayer. I used an IBM printer “typewriter ball” brush that has medium stiff plastic bristles don’t fall off the brush (ie. you don’t want any bristles to remain in the assembly). Note that all the Figures in this document are “post repair” and show that I thoroughly removed all ink residue (except from normal staining) from the purge unit.
- 4) If you can be equally as careful and agile with the sprayer, you can also flush through old ink that accumulates in the foam under the print head carriage area (see the red box in Figure 4 below). I did not brush that foam, only flushed it.

- 5) Although not pictured in Figure 4, all the way on the left side of this print head carriage foam area, there is a little clear plastic ink “drain chute” (that drains forward and down) that you can clean up while you’re there.

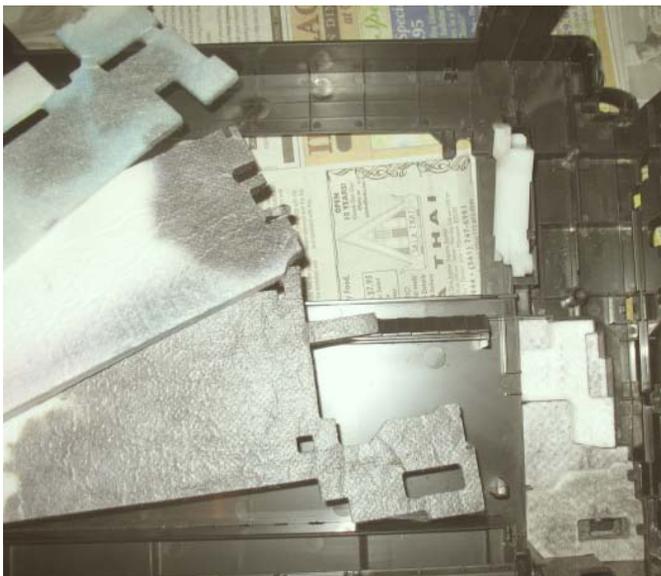
- 10) Since the bottom case is already off, clean the stained waste tank absorbent pads. I had already done this a couple years ago after I tested a new external “continuous” ink tank product. Unfortunately, it leaked about ten ounces of ink into the printer. For reassembly reference, the pads are stacked in Figure 6 and Figure 7 below to show you their correct order:

Although not shown in Figure 6, there is a white pad that runs from front to back on the left side. Could be considered pad# 1. It has never seen one drop of ink. Perhaps it's just an overflow pad for the longer "left-right oriented" pads shown in Figure 6 that are on top of it.

Still looking at Figure 6, you see the longer "left-right oriented" pads. I have shown them in a staggered fashion to show how they are stacked.

On the far right in Figure 6, we see the top three of the smaller pads. There are two small ones that sit on top of a larger one. In Figure 7, I have removed the two smaller pads. Now you see larger one (that I moved towards the top of the picture). You can also see the almost square pad (in place at the bottom of the picture) that is at the bottom of the tank. Do not miss removing this one at the bottom tank! Before removal and cleaning, it is solid black and is very easy to overlook.

How to clean these pads is well documented on the web, but basically you carefully remove them from the bottom cover, then hold them and run cool water over/through them until no ink comes out (about 15 minutes per pad). Do not attempt to wring them out or squeeze the life out of them. To dry them, I laid them out on an old towel for a couple hours until most of the water (and some residual ink) had wicked out into the towel. Then I let them air dry for a couple days (a breeze and sunshine helps too). A web post I saw says they put them in a 100°F oven for a couple hours, but I haven't tried that method (ie. don't want to melt or burn what I can't replace).
